# MineWolf Tiller Test and Evaluation

Technical Report

DRDC Suffield TR 2007-164

November 2007

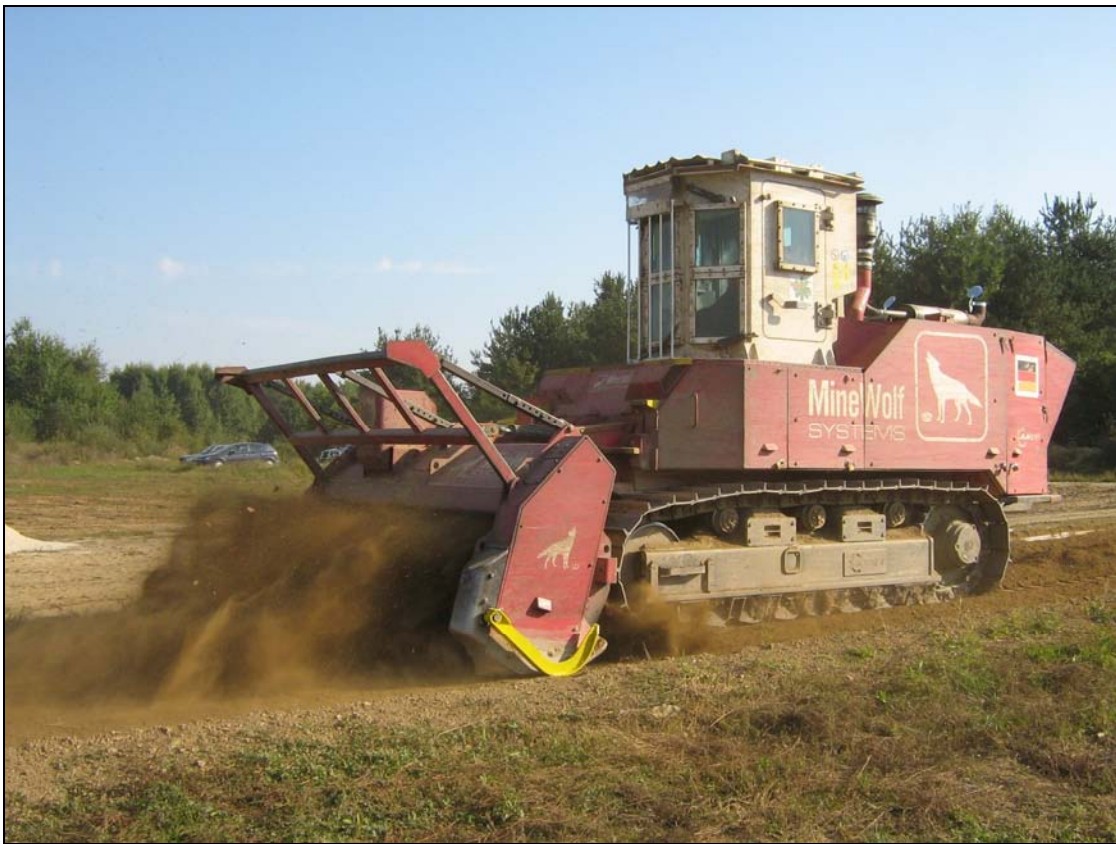
The MineWolf tiller is reported to weigh 25.5 tonnes. It has an overall width of 3.48 metres and an active width (the width across the ground engaging section of the tiller head) of 2.8 metres. A machine this size is generally classed as a heavy machine. Figure 1 and Figure 2 provide general views of the MineWolf and the tiller head.

The machine is equipped with a Deutz diesel engine rated at 270kW (367hp). The tiller head is fitted with 72 chisels along a shaft rotating at up to 480 rpm. The chisels are arranged around the shaft on 12 plates.

*Figure 1. MineWolf tiller*

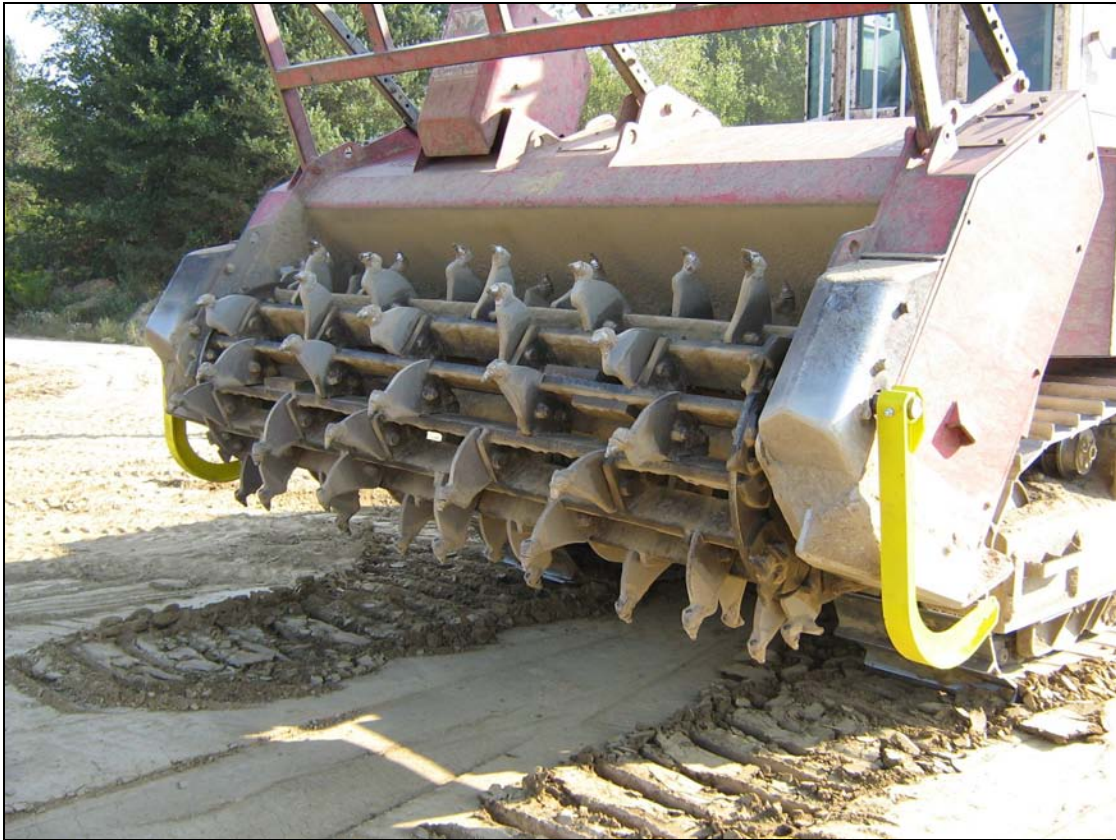
**Figure 2.** MineWolf Tiller Head

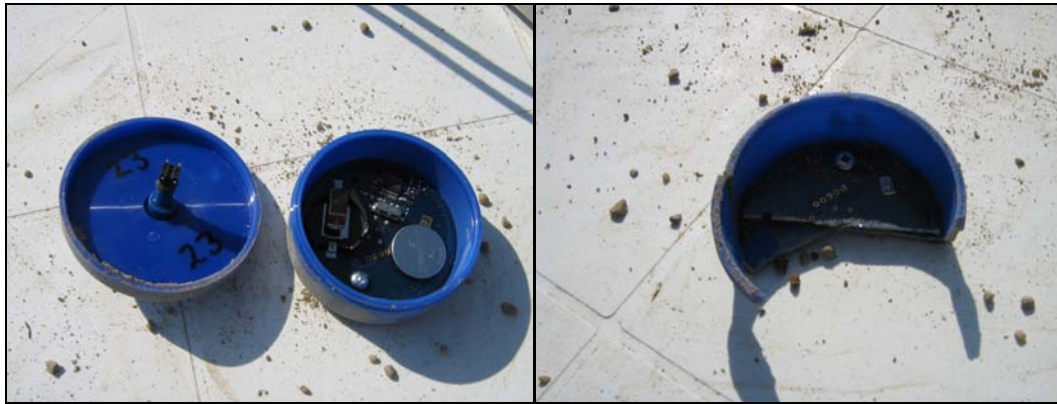
Mechanically neutralised

**Figure 5.** *Debris of Interest – Gravel, 0cm DOB*

The images in Figure 5 through Figure 13 show some of the debris collected following each trial. The test data sheets contained in Annex D describe the status of each WORM target. The reader is invited to draw his or her own conclusions about the type of the debris left in and around the area where the MineWolf has been used.

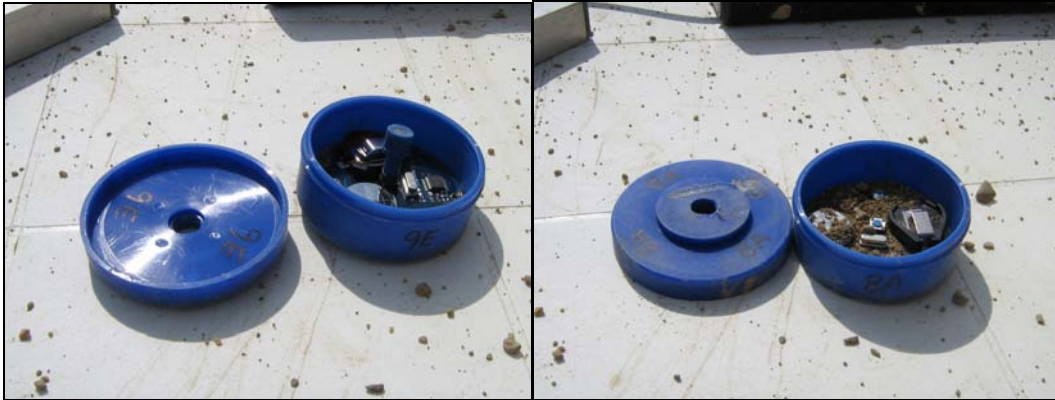
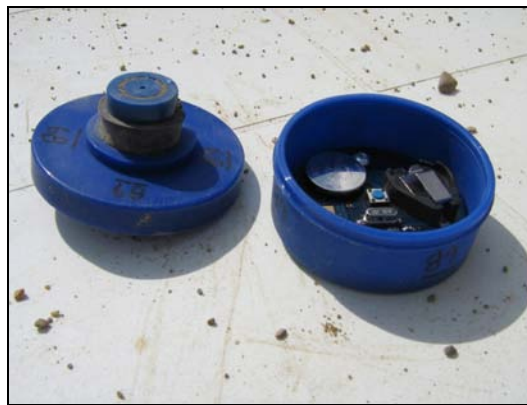
Live damaged

Mechanically neutralised

**Figure 6.** Debris of Interest – Gravel, 10cm DOB

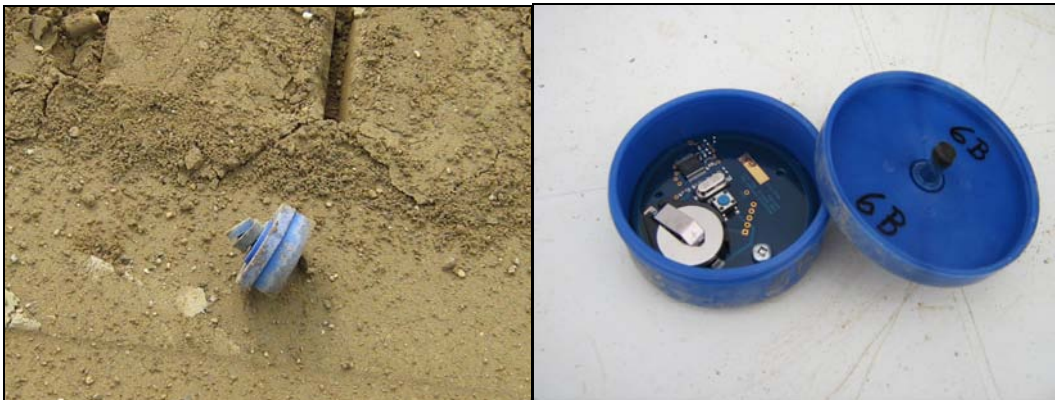
unknown serial thrown outside  
of test lane

Live damaged

**Figure 7.** Debris of Interest – Gravel, 15cm DOB

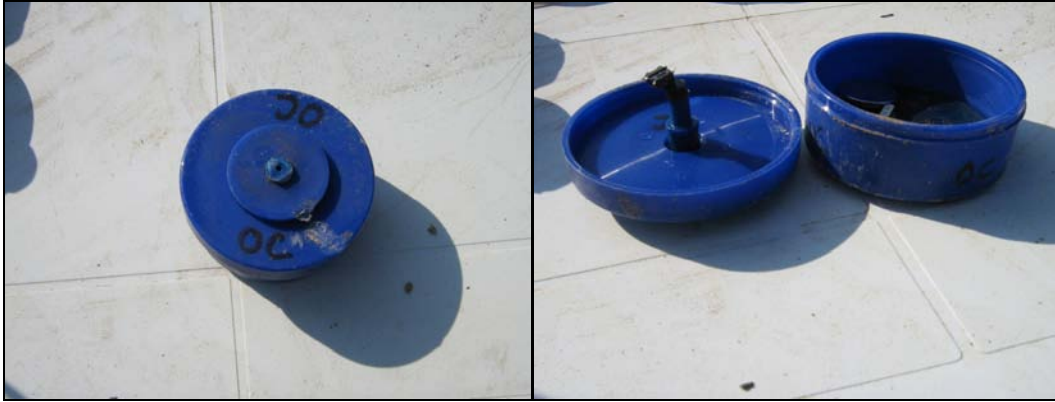
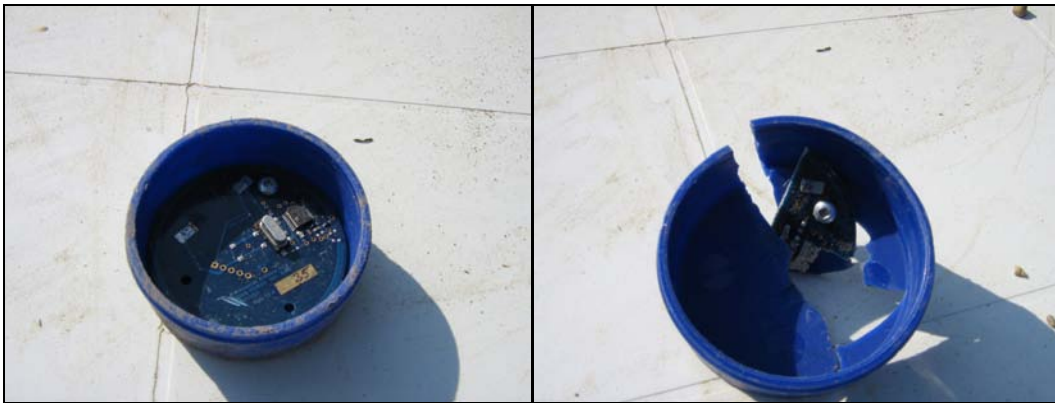
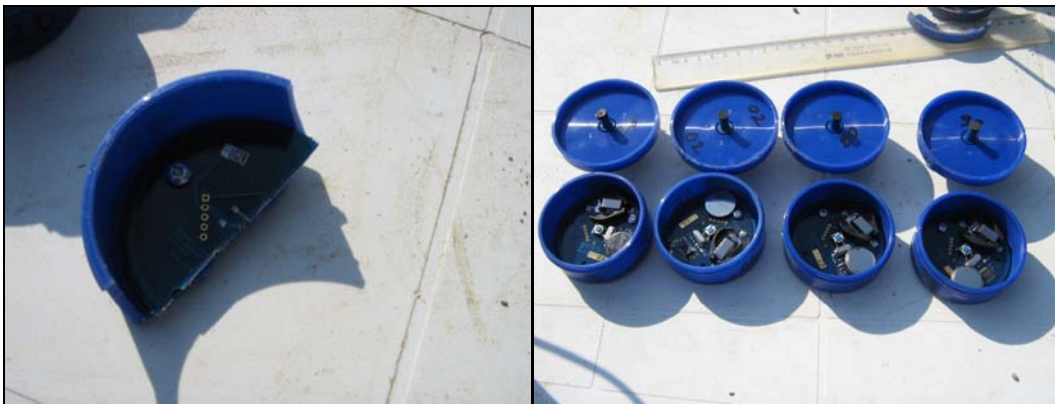
Triggered (same target)

Triggered

Mechanically neutralised

Live damaged

**Figure 8.** Debris of Interest –Sand, 0cm DOB

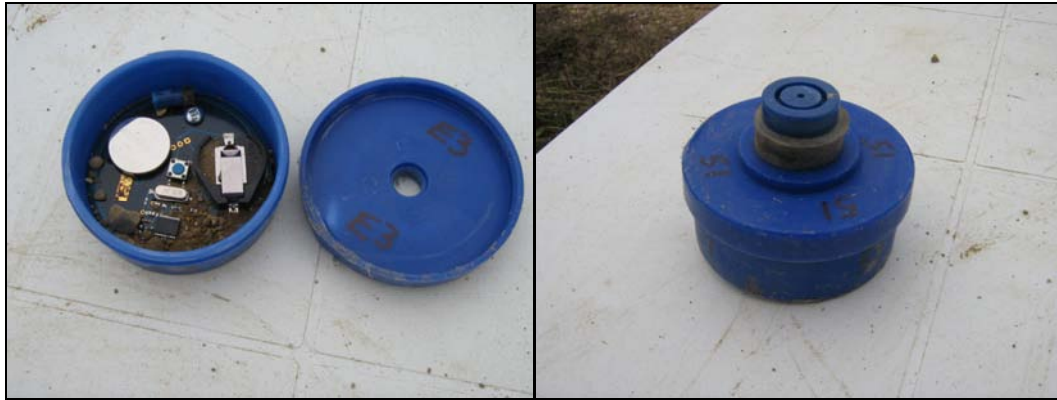
Live damaged

Live

**Figure 9.** Debris of Interest – Sand, 10cm DOB

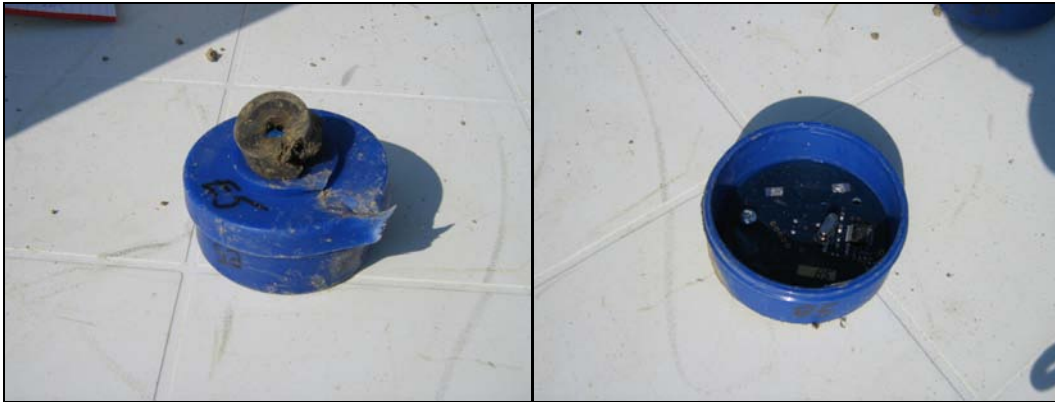
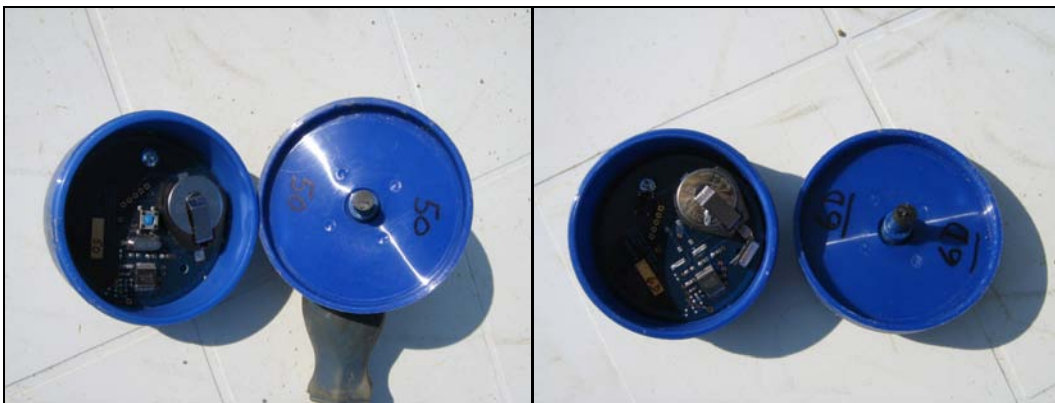
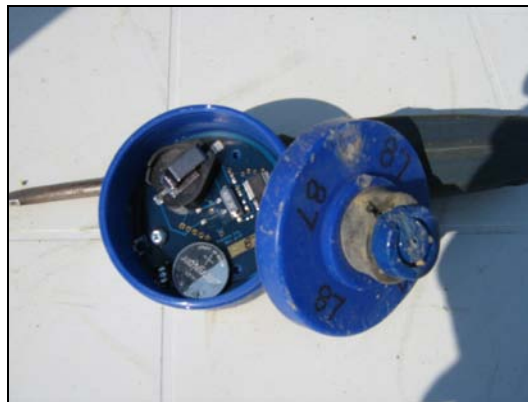
Triggered

Mechanically neutralised

**Figure 10.** Debris of Interest – Sand, 15cm DOB

The worst performance achieved is 41/50 at 15cm in sand. The reasons for the poorer performance in these conditions were not fully examined during these trials. The manufacturer indicated awareness of this issue and has increased the tiller rotation speed for operation in sand conditions such as Jordan and United Arab Emirates.

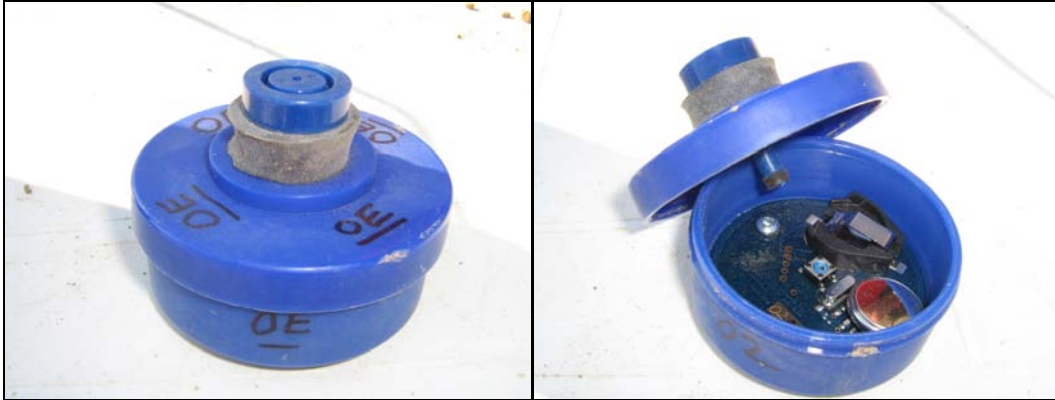
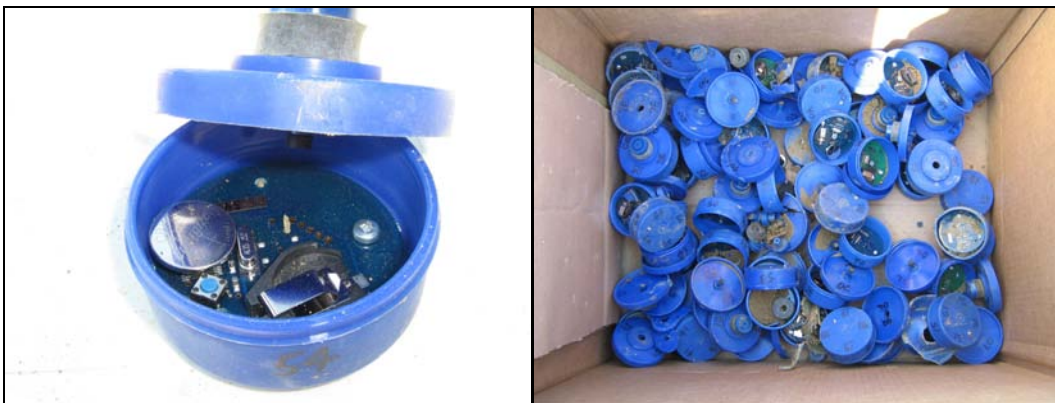
Live damaged

Triggered

General debris from trial

**Figure 11.** Debris of Interest – Topsoil, 0cm DOB

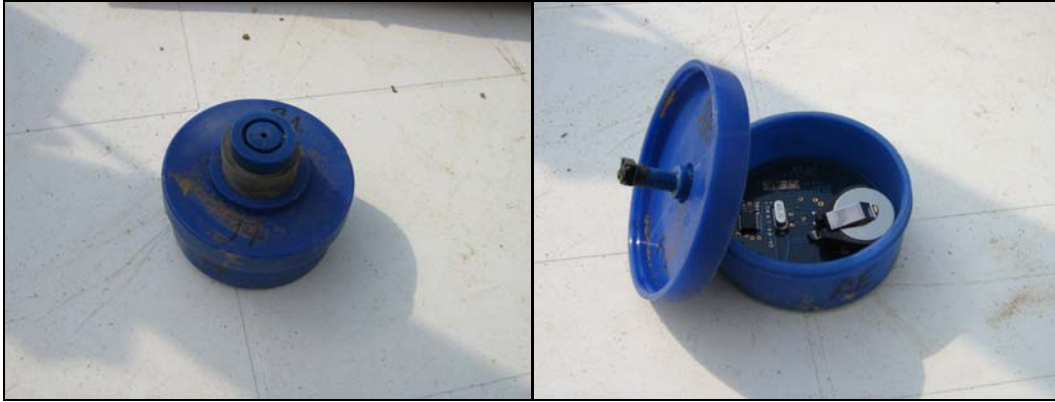
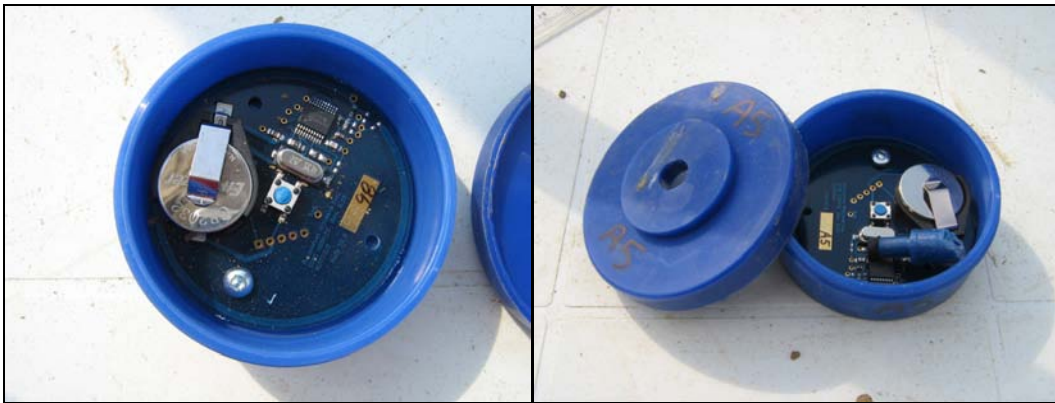
Live

Triggered

**Figure 12.** Debris of Interest – Topsoil, 10cm DOB

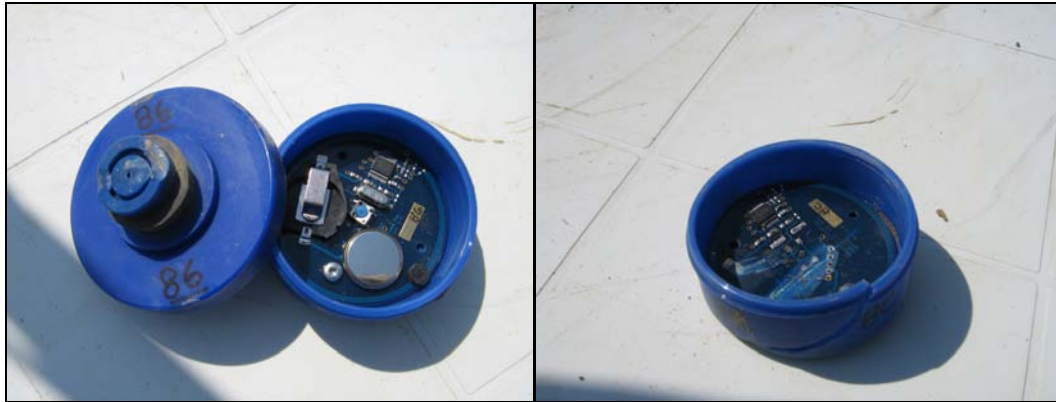
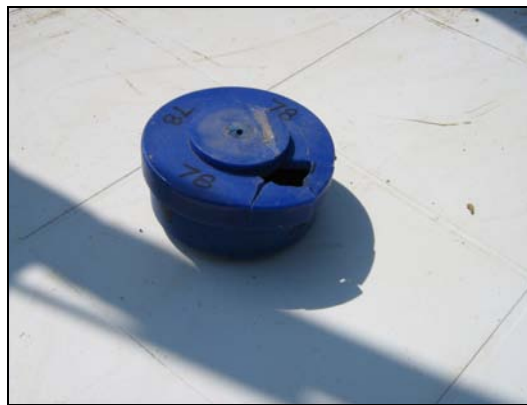
Triggered

Mechanically neutralised

**Figure 13.** Debris of Interest – Topsoil, 15cm DOB

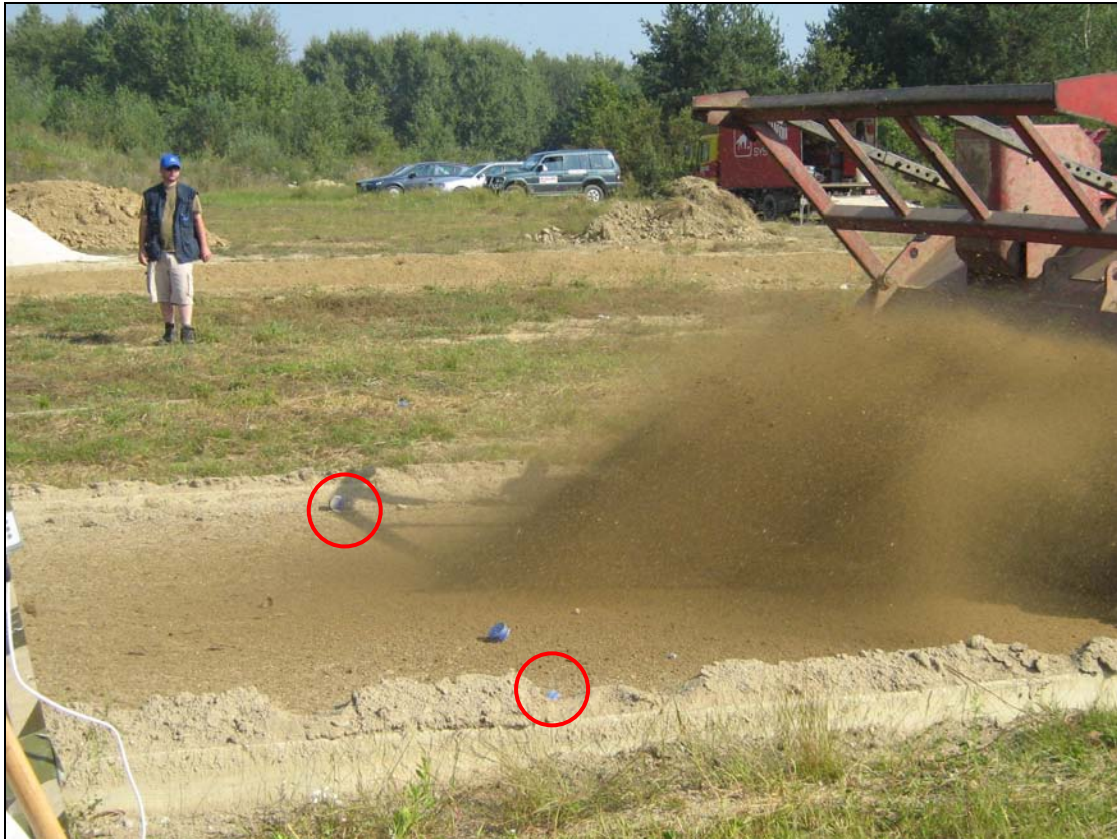
Along with the items shown above, remains from the targets which were completely destroyed could be found in and around the test lanes. Although not as vigorous in throwing debris as a conventional chain flail, the MineWolf is prone to throwing soil, mine fragment debris, and potentially vegetation (see Figure 14) to a limited extent.

*Figure 14. Debris Thrown from Tiller After Processing*

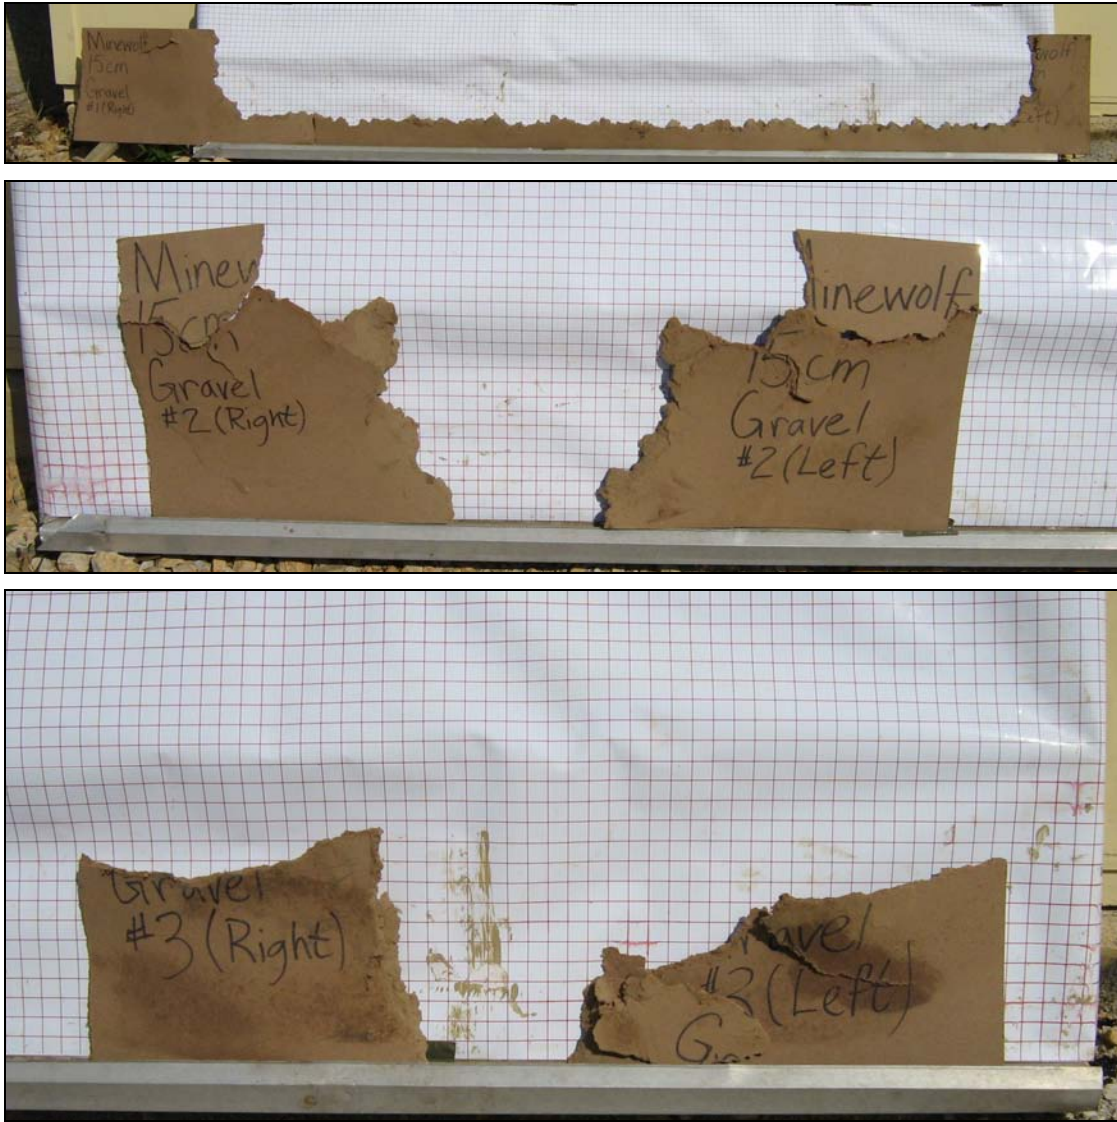
The fibreboards in Figure 18, Figure 19 and Figure 20 show an even depth penetration of 14cm or deeper. As with the sand, the test lane with the targets buried at 10cm showed the least penetration, with the 0cm and 15cm test lanes recording 24cm and 30cm penetration respectively. There is no other apparent evidence of skip zones in this test.

Similar to the sand test lanes, only one out of the three boards in each of the 0cm and 15cm test lanes were recovered intact. Again the machine dug deeper than the boards.

**Figure 20.** Depth of Penetration in Gravel with mines at 15 cm DOB

The machine also was able to penetrate consistently and uniformly to a depth of 14cm or greater in the gravel conditions used in these tests. Again, there was no evidence of skip zones.

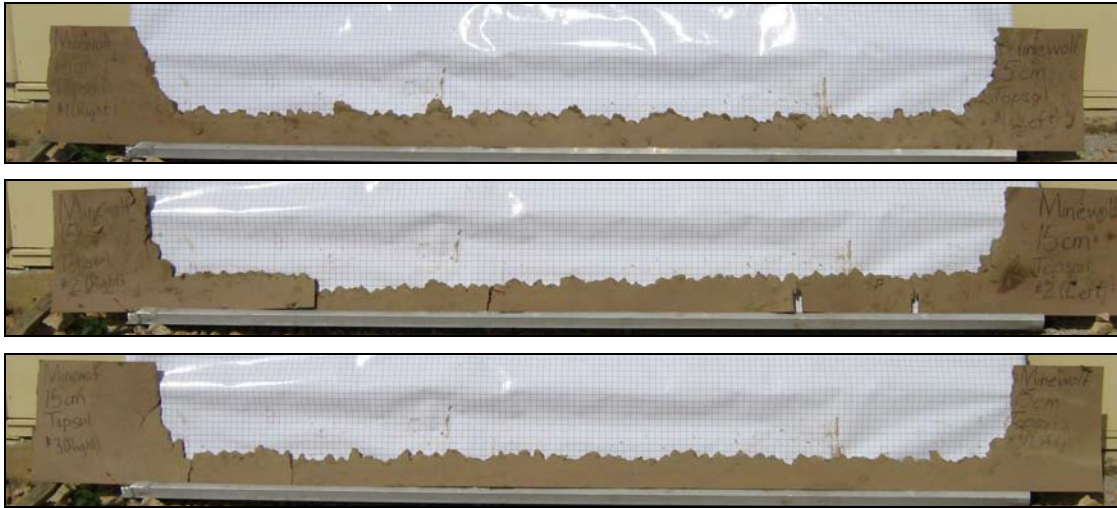
The fibreboards in Figure 21, Figure 22 and Figure 23 show an even depth penetration of 16cm or deeper. As with the sand and gravel, the test lane with the targets buried at 10cm showed the least penetration, with the 0cm and 15cm test lanes recording 30cm and 28cm penetration respectively. There is no other apparent evidence of skip zones in this test.

**Figure 23.** *Depth of Penetration in Topsoil with mines at 15 cm DOB*

The machine also was able to penetrate consistently and uniformly to a depth of 16cm or greater in the topsoil conditions used in these tests. Again, there was no evidence of skip zones.

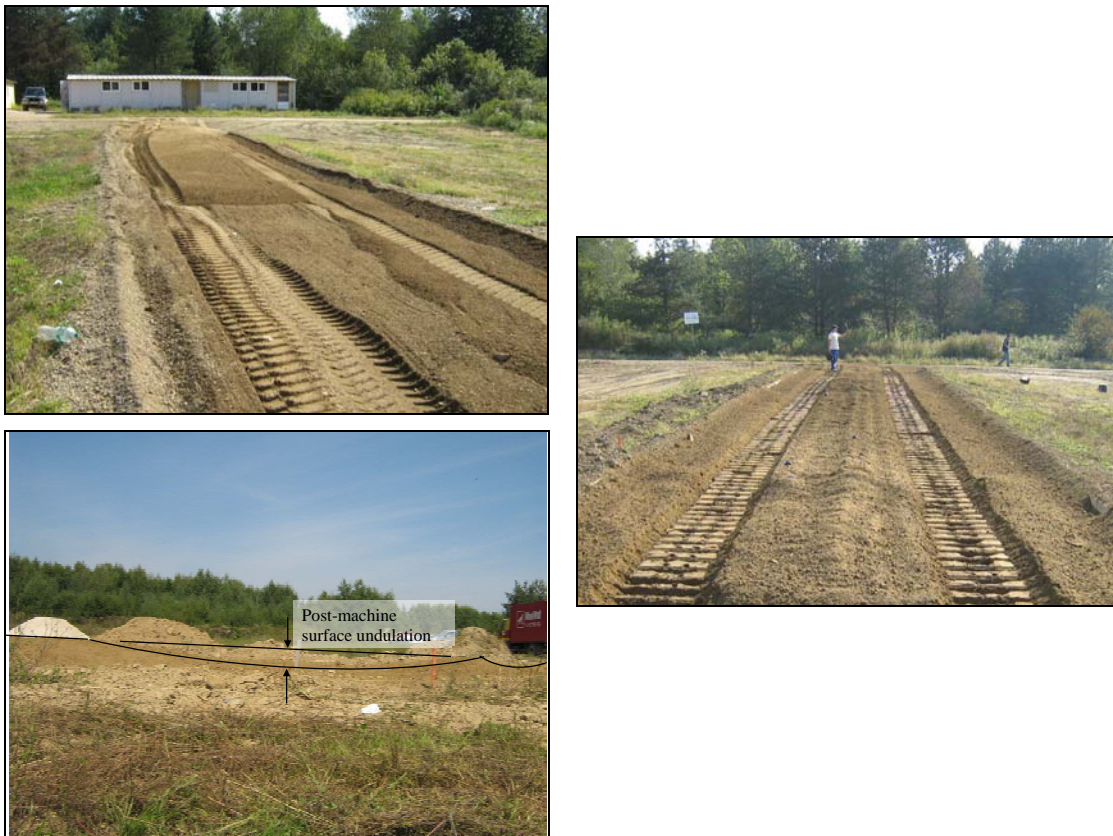
The difference in surface soil profile following the passage of the machine with and without automatic depth control is interesting to note (Figure 24). The differences are quite significant as terrain which was originally flat and level shows a sinusoidal pattern following the passage of the machine without automatic depth control. The photograph shown in Figure 24 has terrain undulations in excess of 15cm after the passage of the MineWolf without depth control over almost completely flat terrain. This is corroborated by the videos taken of the trials that clearly show the tiller head moving up and down by what appears to be 15cm. Conversely, the soil surface following the passage of the MineWolf with automatic depth control is quite flat with no significant undulations.

4. As the MineWolf descends the rise created from the higher pile of soil, the tiller head digs in more, resulting in a larger pile of soil behind the tiller head as in (1) above.

The cycle listed above in Steps 1 to 4 repeats itself along the length of the test lane. Since there is no sudden increase or decrease in the height of the ground or tiller head, the operator has no indication that this sequence is occurring. A long, gentle, sinusoidal pattern is created in the surface of the ground following the passage of the tiller, presumably resulting in a similar trend in the maximum digging depth of the machine. Even if the operator is able to recognize that the undulation is occurring, any correction will likely exacerbate the problem as the machine will be on a different part of the undulating pattern than the working head.

**Figure 24.** Terrain After Passage Of MineWolf Without (Left) and With (Right) Automatic Depth Control

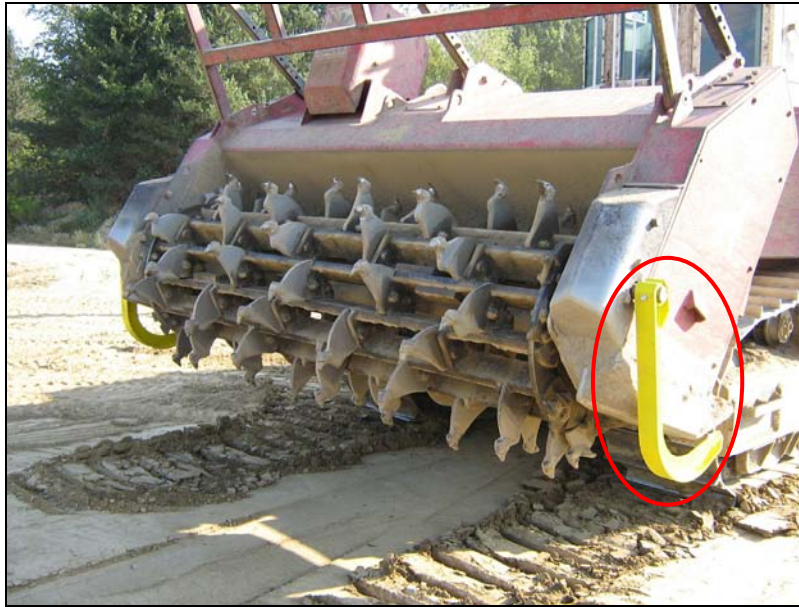
**Figure 25.** Automatic Depth Control Hardware

With the automatic depth control system, the tiller head is kept at a relatively constant height with respect to the original ground surface. The small skis outboard and on each side of the tiller head shown in Figure 25 provide a ground height signal to control depth of cut. The control system proved effective at eliminating the sinusoidal pattern of the ground resulting from manually controlling tiller depth. This system was not tested in undulating terrain but is presumed to be effective for the reasons discussed above.

Clearly the depth control skis are quite open and may be exposed to damage from vegetation and blast in their current configuration. As a result, MKA reported that they do not routinely employ them. The incorporation of some sort of protection, particularly from vegetation from the front and side would probably help to alleviate this problem.

The depth control on the MineWolf appears to be effective *when used*. Additional effort should be placed on making the depth control system sufficiently rugged that the user (MKA Demining in this case) does not remove it due to frequent damage.

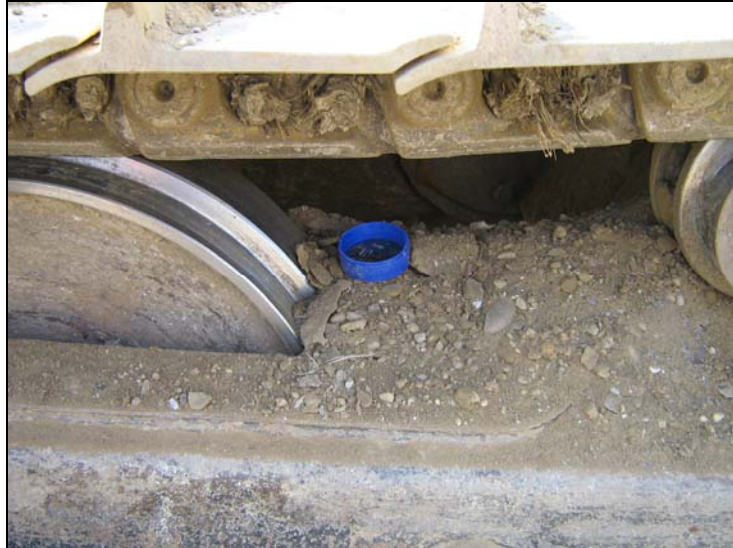
The track of the MineWolf causes concern with respect to trapping potentially hazardous debris. Figure 26 shows the area under the track where one of the targets was found after a trial. Although this target had been neutralised, it is not difficult to imagine a situation where this could have been a hazardous piece of UXO or a live mine as not all of the targets were neutralised or triggered by the tiller. Modifying the profile of the structural members within the track system may help to eliminate this problem.

*Figure 26. Debris Collects Around Tracks*

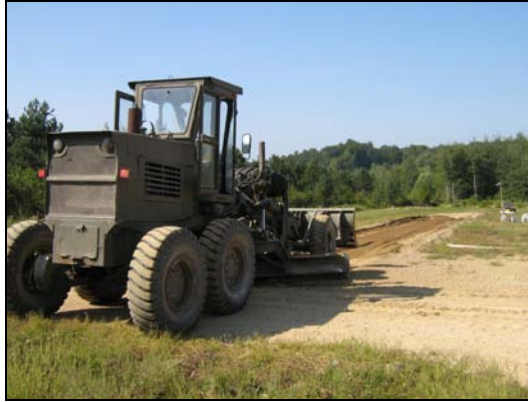
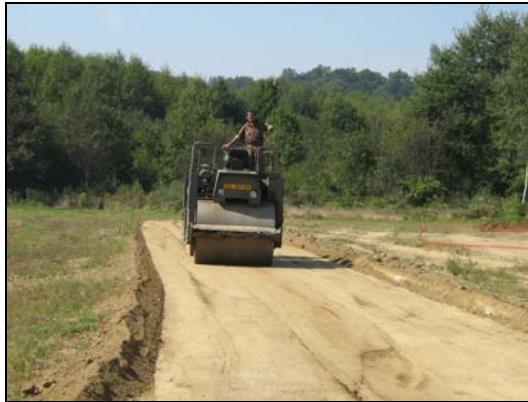
The soil in each test lane was prepared as follows. Prior to a test the soil was loosened with a piece of ground engaging equipment, such as the flail or tiller under test. The soil was then levelled using a grader and compacted using the vibratory compacter as shown in Figure A-1. The soil compaction and moisture content were monitored to ensure consistent test conditions.

**Figure A-1.** *Soil Preparation – Grading and Compacting The Soil*

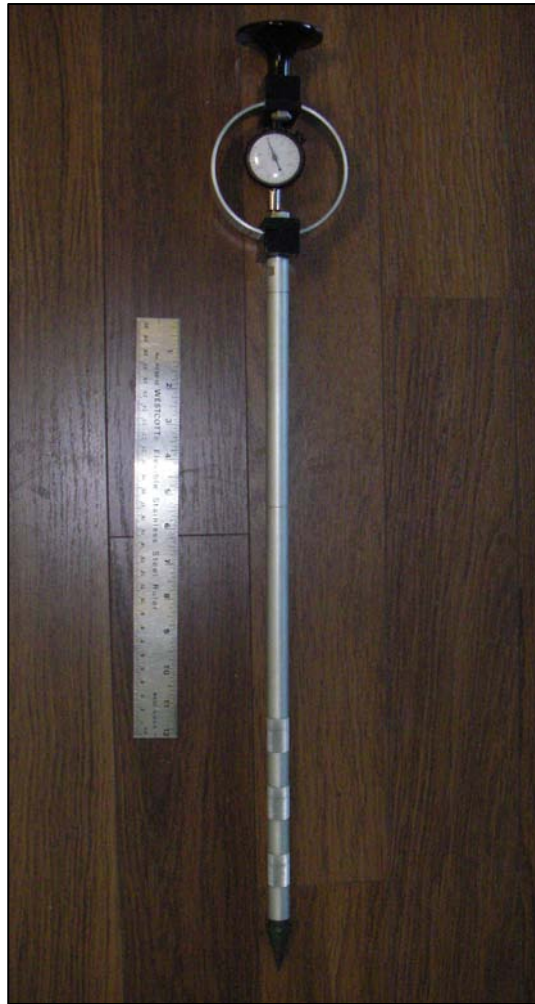
**Figure A-2.** Soil Cone Penetrometer

The maintenance of consistent soil conditions for each passage of the machine was critical to ensure that useful test data was collected. During the soil preparation operations, a cone penetrometer was used to determine the consistency of the soil. An example of a cone penetrometer is shown in Figure A-2. Cone index readings in excess of approximately 100 psi were considered acceptable to proceed with the trial as soil conditions with lower cone index readings would not be trafficable by a significant number of vehicles. Excessively low cone index readings generally occurred when the moisture content of the soil was very high; these test areas were left to dry until higher cone index readings were obtained.

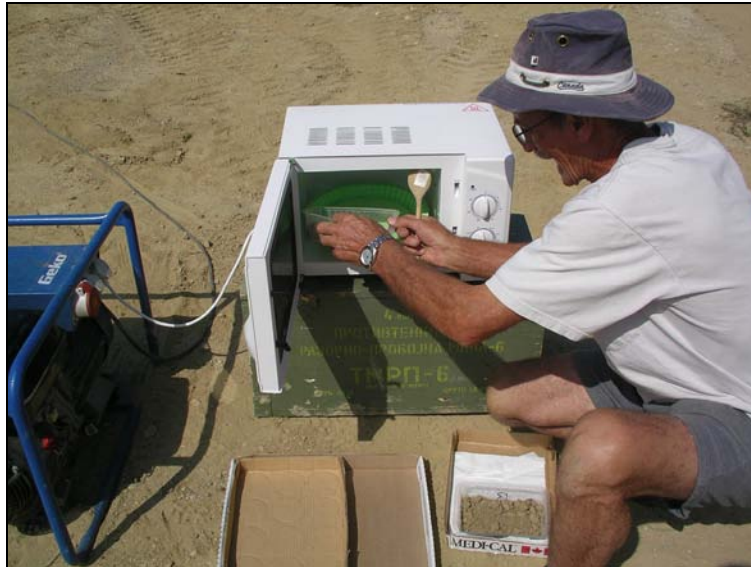
Compaction and moisture content were measured using manual methods described in Annex C. Photographs of the soil drying are shown in Figure A-3. For each test lane, three samples were taken.

**Figure A-3.** Soil Drying Using a Microwave

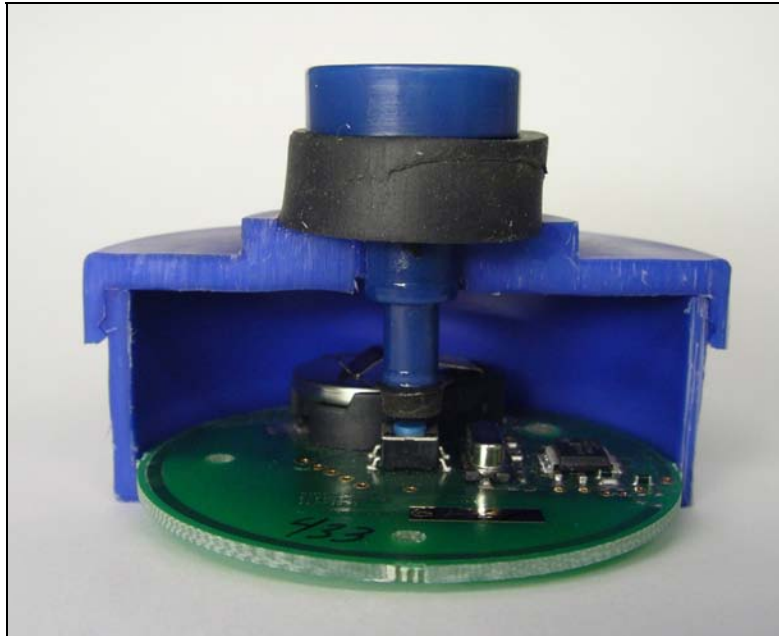
**Figure A-4** *Cut-away View of WORM Test Target*

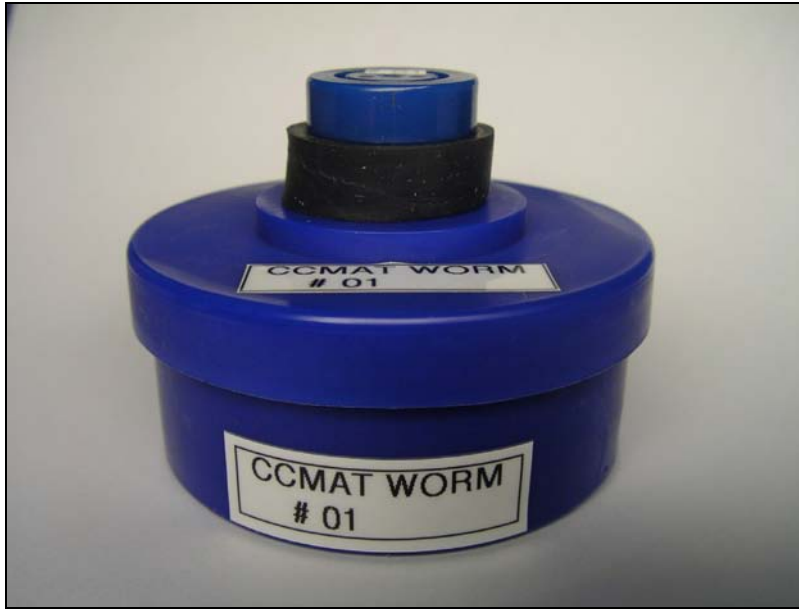
**Figure A-5.** WORM Antipersonnel Mine Surrogate

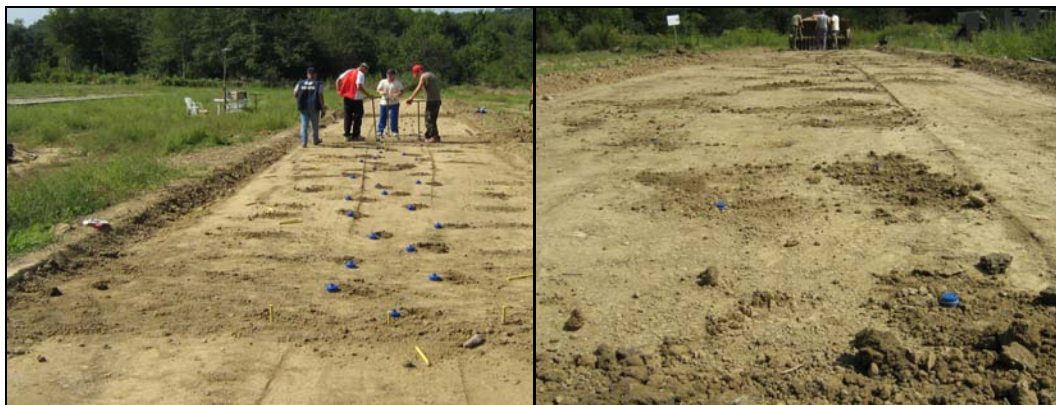
The targets were located approximately 0.5m apart to minimize the possibility of more than one target triggering at once. They were laid in a path whose width was approximately 50% of the width of the machine working tool. In other words, a machine with a 2 metre wide tool would have targets spread approximately 0.5m on either side of the machine centreline, for a total path width of 1 metre. The layout of the test targets is shown in Figure A-6.

**Figure A-6.** WORM Test Lane Layout

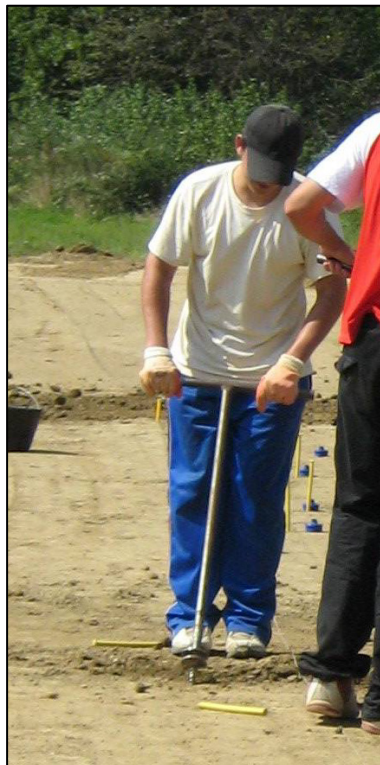
**Figure A-8.** Mine Target Burial Tool To Minimize Soil Disturbance

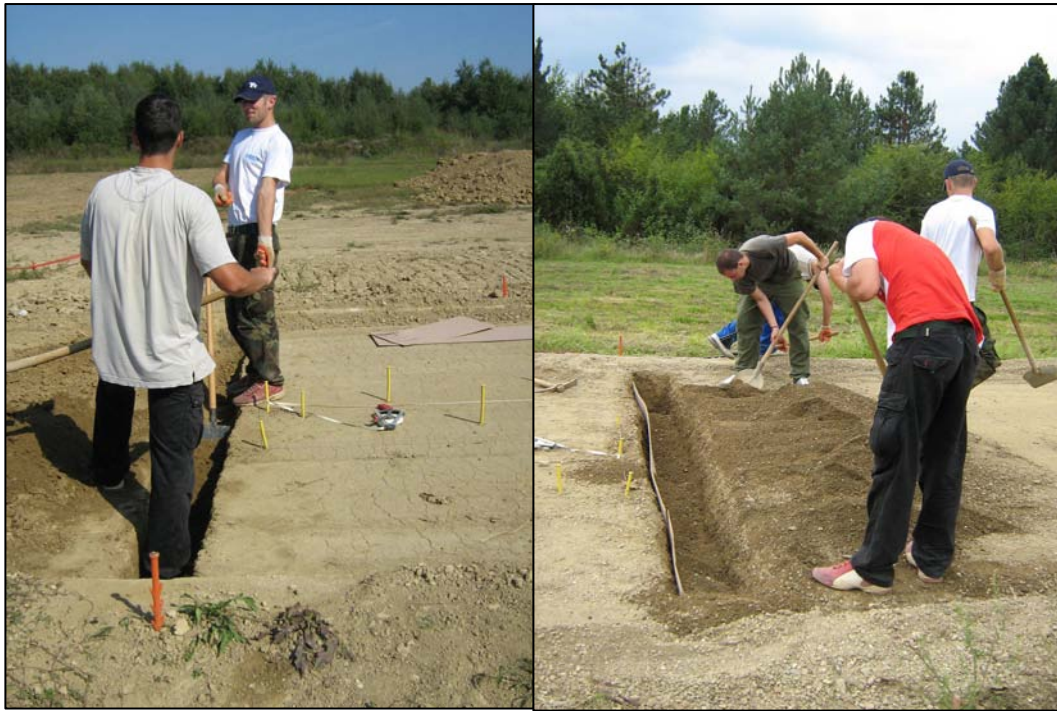
A narrow trench was dug by hand across the width of the test area to accommodate the witness boards. The width of the trench was kept to a minimum to reduce the effects of the softer replacement soil on tiller penetration. The fiberboard was placed against the side of the trench nearest the start line of the machine. This technique reduces the chances of the witness board being removed by the tool rather than simply cutting into it. Figure A-10 illustrates a trench being dug.

**Figure A-10. Witness Board Installation**

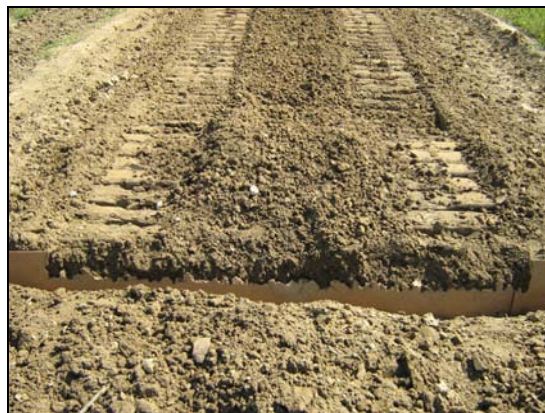
The witness board was buried flush with the surface, acting as a witness panel to record the depth of penetration of the tool. A photograph of a partially excavated witness board is shown in Figure A-11. No direct indication of the force or neutralisation effectiveness of the tool at any depth is provided, however a clear indication of the consistency of soil cutting is provided. This indicator is obviously only useful for soil penetrating machines such as flails and tillers and cannot be used for low-disturbance tools such as rollers.

**Figure A-11. Witness Board Partially Excavated**

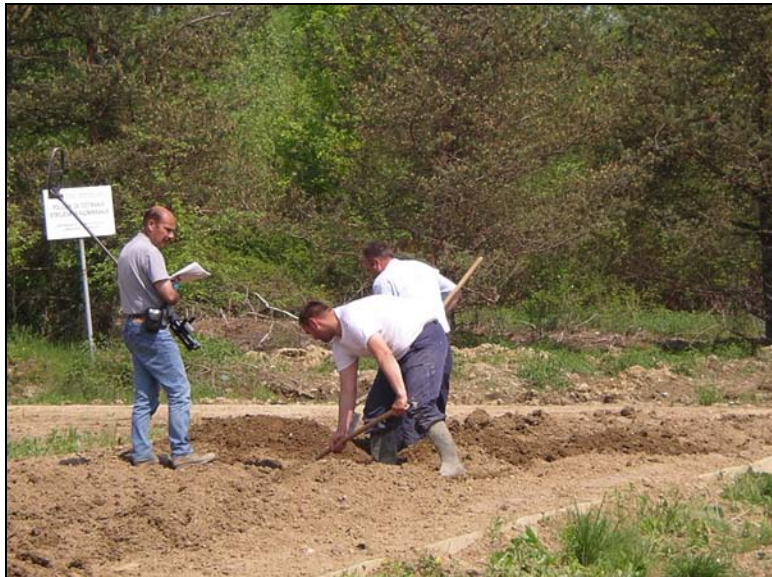
After the passage of the machine through the test area, the computer recording of WORM trigger signals was stopped. The test lane was examined and visible test targets removed. The computer operator began developing a table of data, such as those shown at Annex D. Recovered test targets were examined to establish status. Other personnel continued to recover test targets using a metal detector to locate them. Once the target recovery team had been through the test lane once, the computer operator noted the targets from which no signal had been received and no status determined. Special attention was given to recovering these targets.

*Figure A-12. Locating Test Targets After Passage of the Machine*
